September 11, 2009  
Project No. 09-4157

**TRANSMITTAL**  
**ASSESSMENT OF DAM SAFETY OF**  
**COAL COMBUSTION SURFACE IMPOUNDMENTS**  
**FIELD ASSESSMENT CHECKLISTS FOR**  
**SITES 24 (MITCHELL) AND 30 (BRUCE MANSFIELD)**

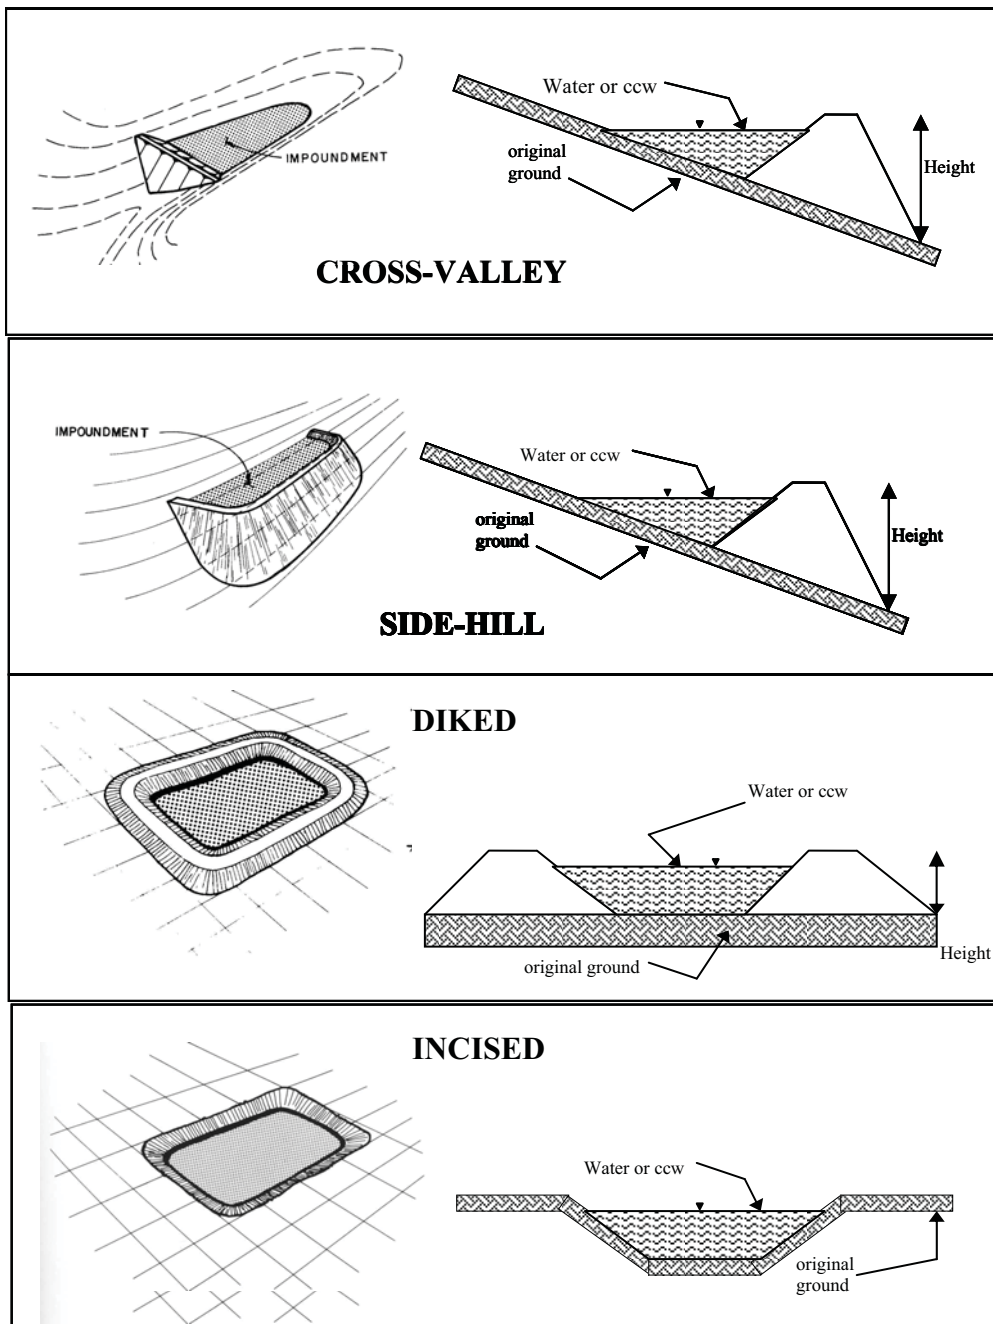
# **CONFIGURATION:**

<input type="checkbox"/>	Cross-Valley		
<input checked="" type="checkbox"/>	Side-Hill		
<input type="checkbox"/>	Diked		
<input type="checkbox"/>	Incised (form completion optional)		
<input type="checkbox"/>	Combination Incised/Diked		
Embankment Height	17	feet	Embankment Material <small>Soil with asphalt on crest and downstream slope</small>
Pool Area	3.1	acres	Liner <small>Asphlat</small>
Current Freeboard	2	feet	Liner Permeability <small>10<sup>-7</sup> cm/s (estimated)</small>
